USAAMRDL TECHNICAL REPORT 73-74

EVALUATION OF VARIOUS SIZES AND CONFIGURATIONS OF FUEL TANKS

FIRESTONE COATED FABRICS COMPANY

Eighteen tanks with a 30-inch x 30-inch base dimension and heights of 48 and 60 inches of qualified crashworthy constructions were impacted from 65 feet. Nine of these failed adjacent to fittings on side panels. All tanks without side fittings passed the impact test regardless of constructions used and with average densities varying from 1.11 to 1.75. Indicated pressures were in the 130-150 psi range for two tanks of Firestone 1550-1 construction and 170-200 psi for a reinforced, heavier revision of this construction.

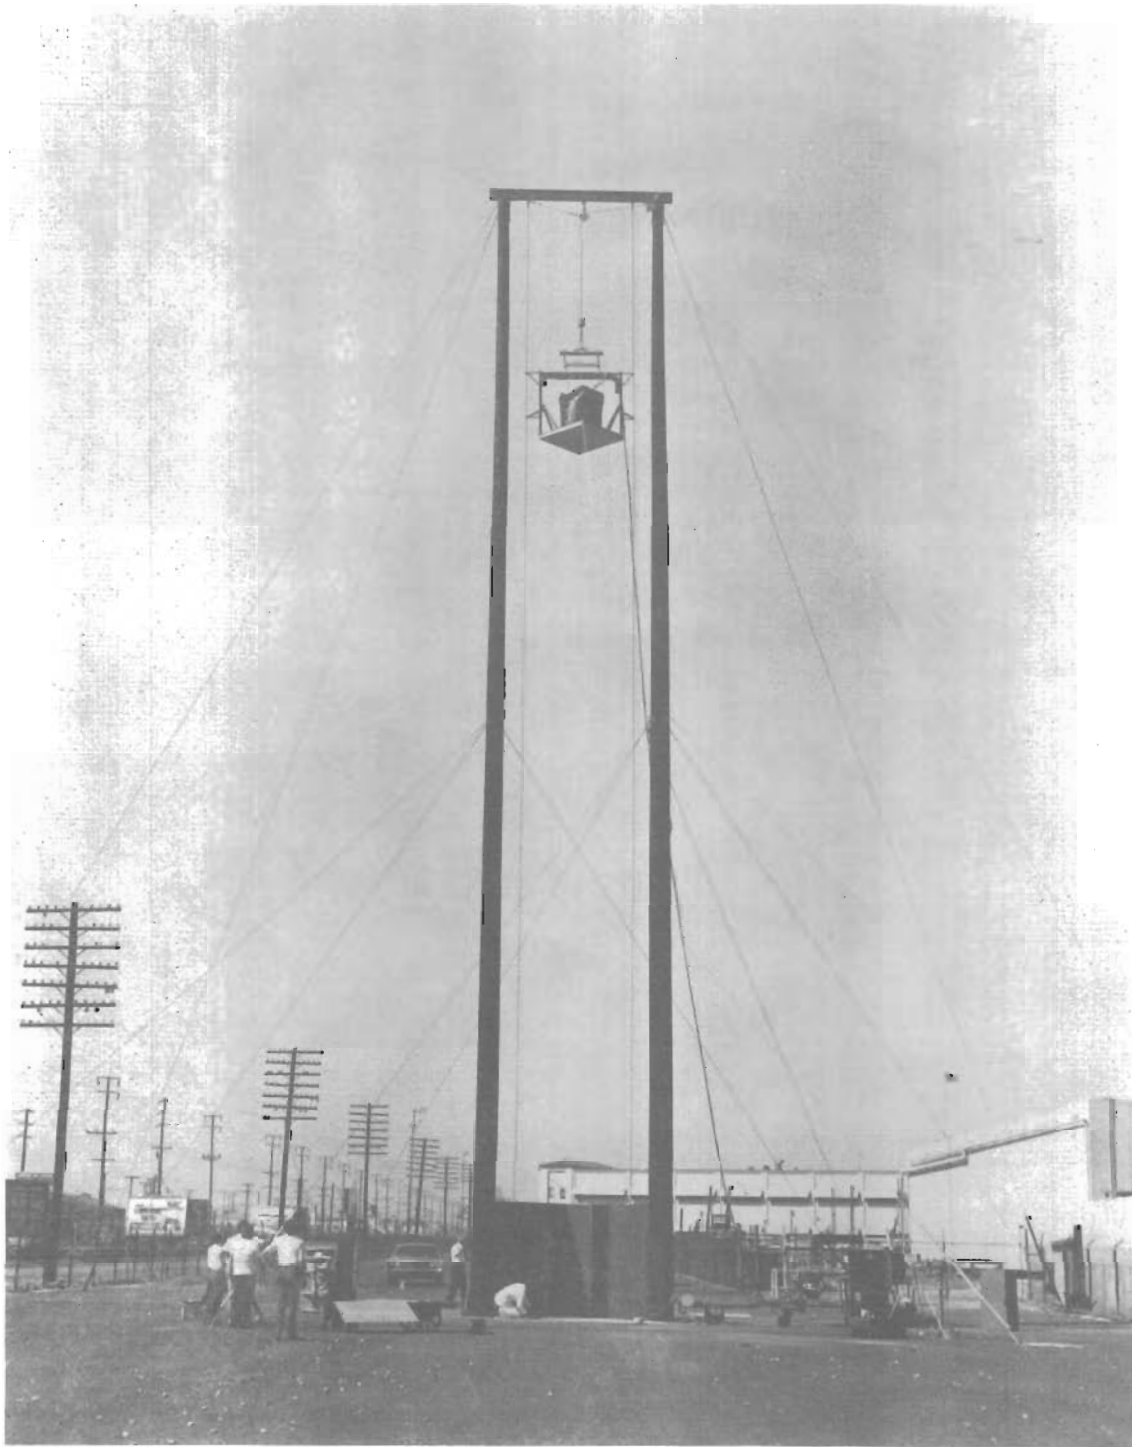
Figure 13. Tower With Test Tank Aloft.

Subsequent to this drop, the fill fixture was used only for strain gage location and to maintain the tank in a simulated "aircraft" configuration while being filled to capacity and evacuated. A number of drops were then performed on a guided platform of the type shown aloft in Figure 13. This platform design caused the rebounding tank to strike the crosspiece between the vertical uprights and threatened damage to the top transducer, cable entry point and cables. The platform release was then redesigned to the configuration shown in Figure 14, wherein the hinged crossarm remained aloft and offered no threat to the instrumentation. Two tanks, however, did fall on the projecting ends of the vertical uprights after rebound; but neither incident resulted in any serious damage to the tanks, and this system was used for the remainder of the drops. All drops were made from 65 feet.

1. The coaxial cables were extremely susceptible to damage. As can be seen in Figure 13, the cables extend from the instrumentation package to the drop platform and are attached to the tower at approximately the midpoint. This, the best of several ways tried, still resulted in a loop which was subject to sway in breezes and snagging on the falling platform.
